**INSPECTION OF COMPOSITES USING A COMPUTER-BASED  
REAL-TIME RADIOGRAPHIC FACILITY**

by Ernest Roberts, Jr., and Alex Vary  
Lewis Research Center  
Cleveland, Ohio 44135

**TECHNICAL PAPER to be presented at the  
Second Conference on Automated  
Inspection and Product Control  
Chicago, Illinois, October 19-21, 1976**

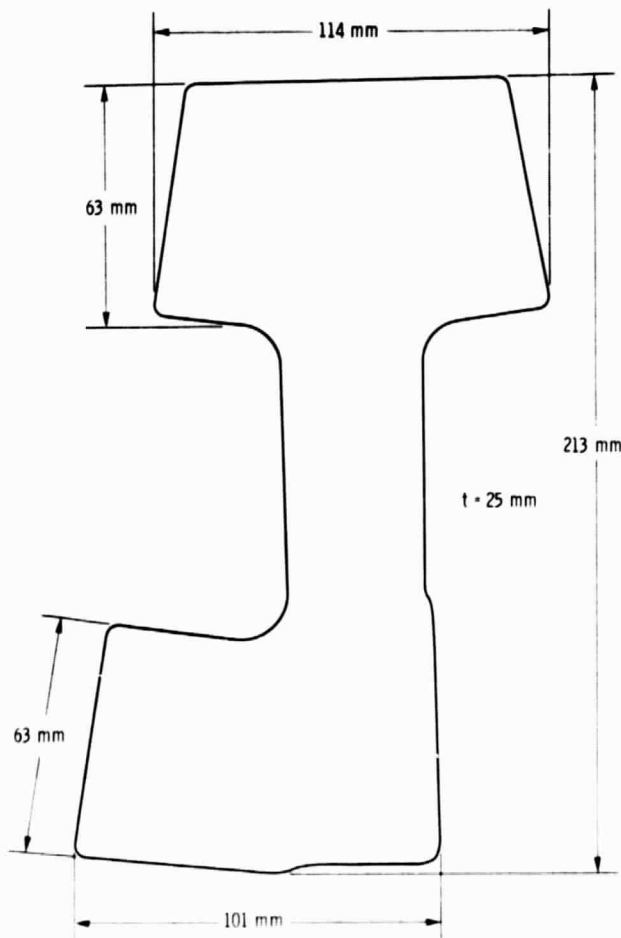
Figure 2. - Sketch of test object.

The test object was a portion of a fan frame ring for an experimental aircraft gas turbine. Its plan view is shown in figure 2. It was fabricated from 10 plies of carbon-fiber-reinforced epoxy composite material. Each ply is approximately 2.5 mm thick, laid-up from pre-impregnated fibers at angles of 0, 45 and 90 degrees. The plies were cured and adhesively bonded together. The region inspected was the junction of the foot with the upright member. Photographs of this region are shown in figure 3, which shows extensive damage near this junction. This damage was incurred during a previous proof test. The purpose of the ultrasonic and X-ray inspections was to reveal the extent of any internal damage. This particular test object was selected because of the ability to confirm the ultrasonic and X-ray indications.
